Building on the Past

By Michael Miyamoto, LC/DBM

Hiding a Slope, Pinpointing a House

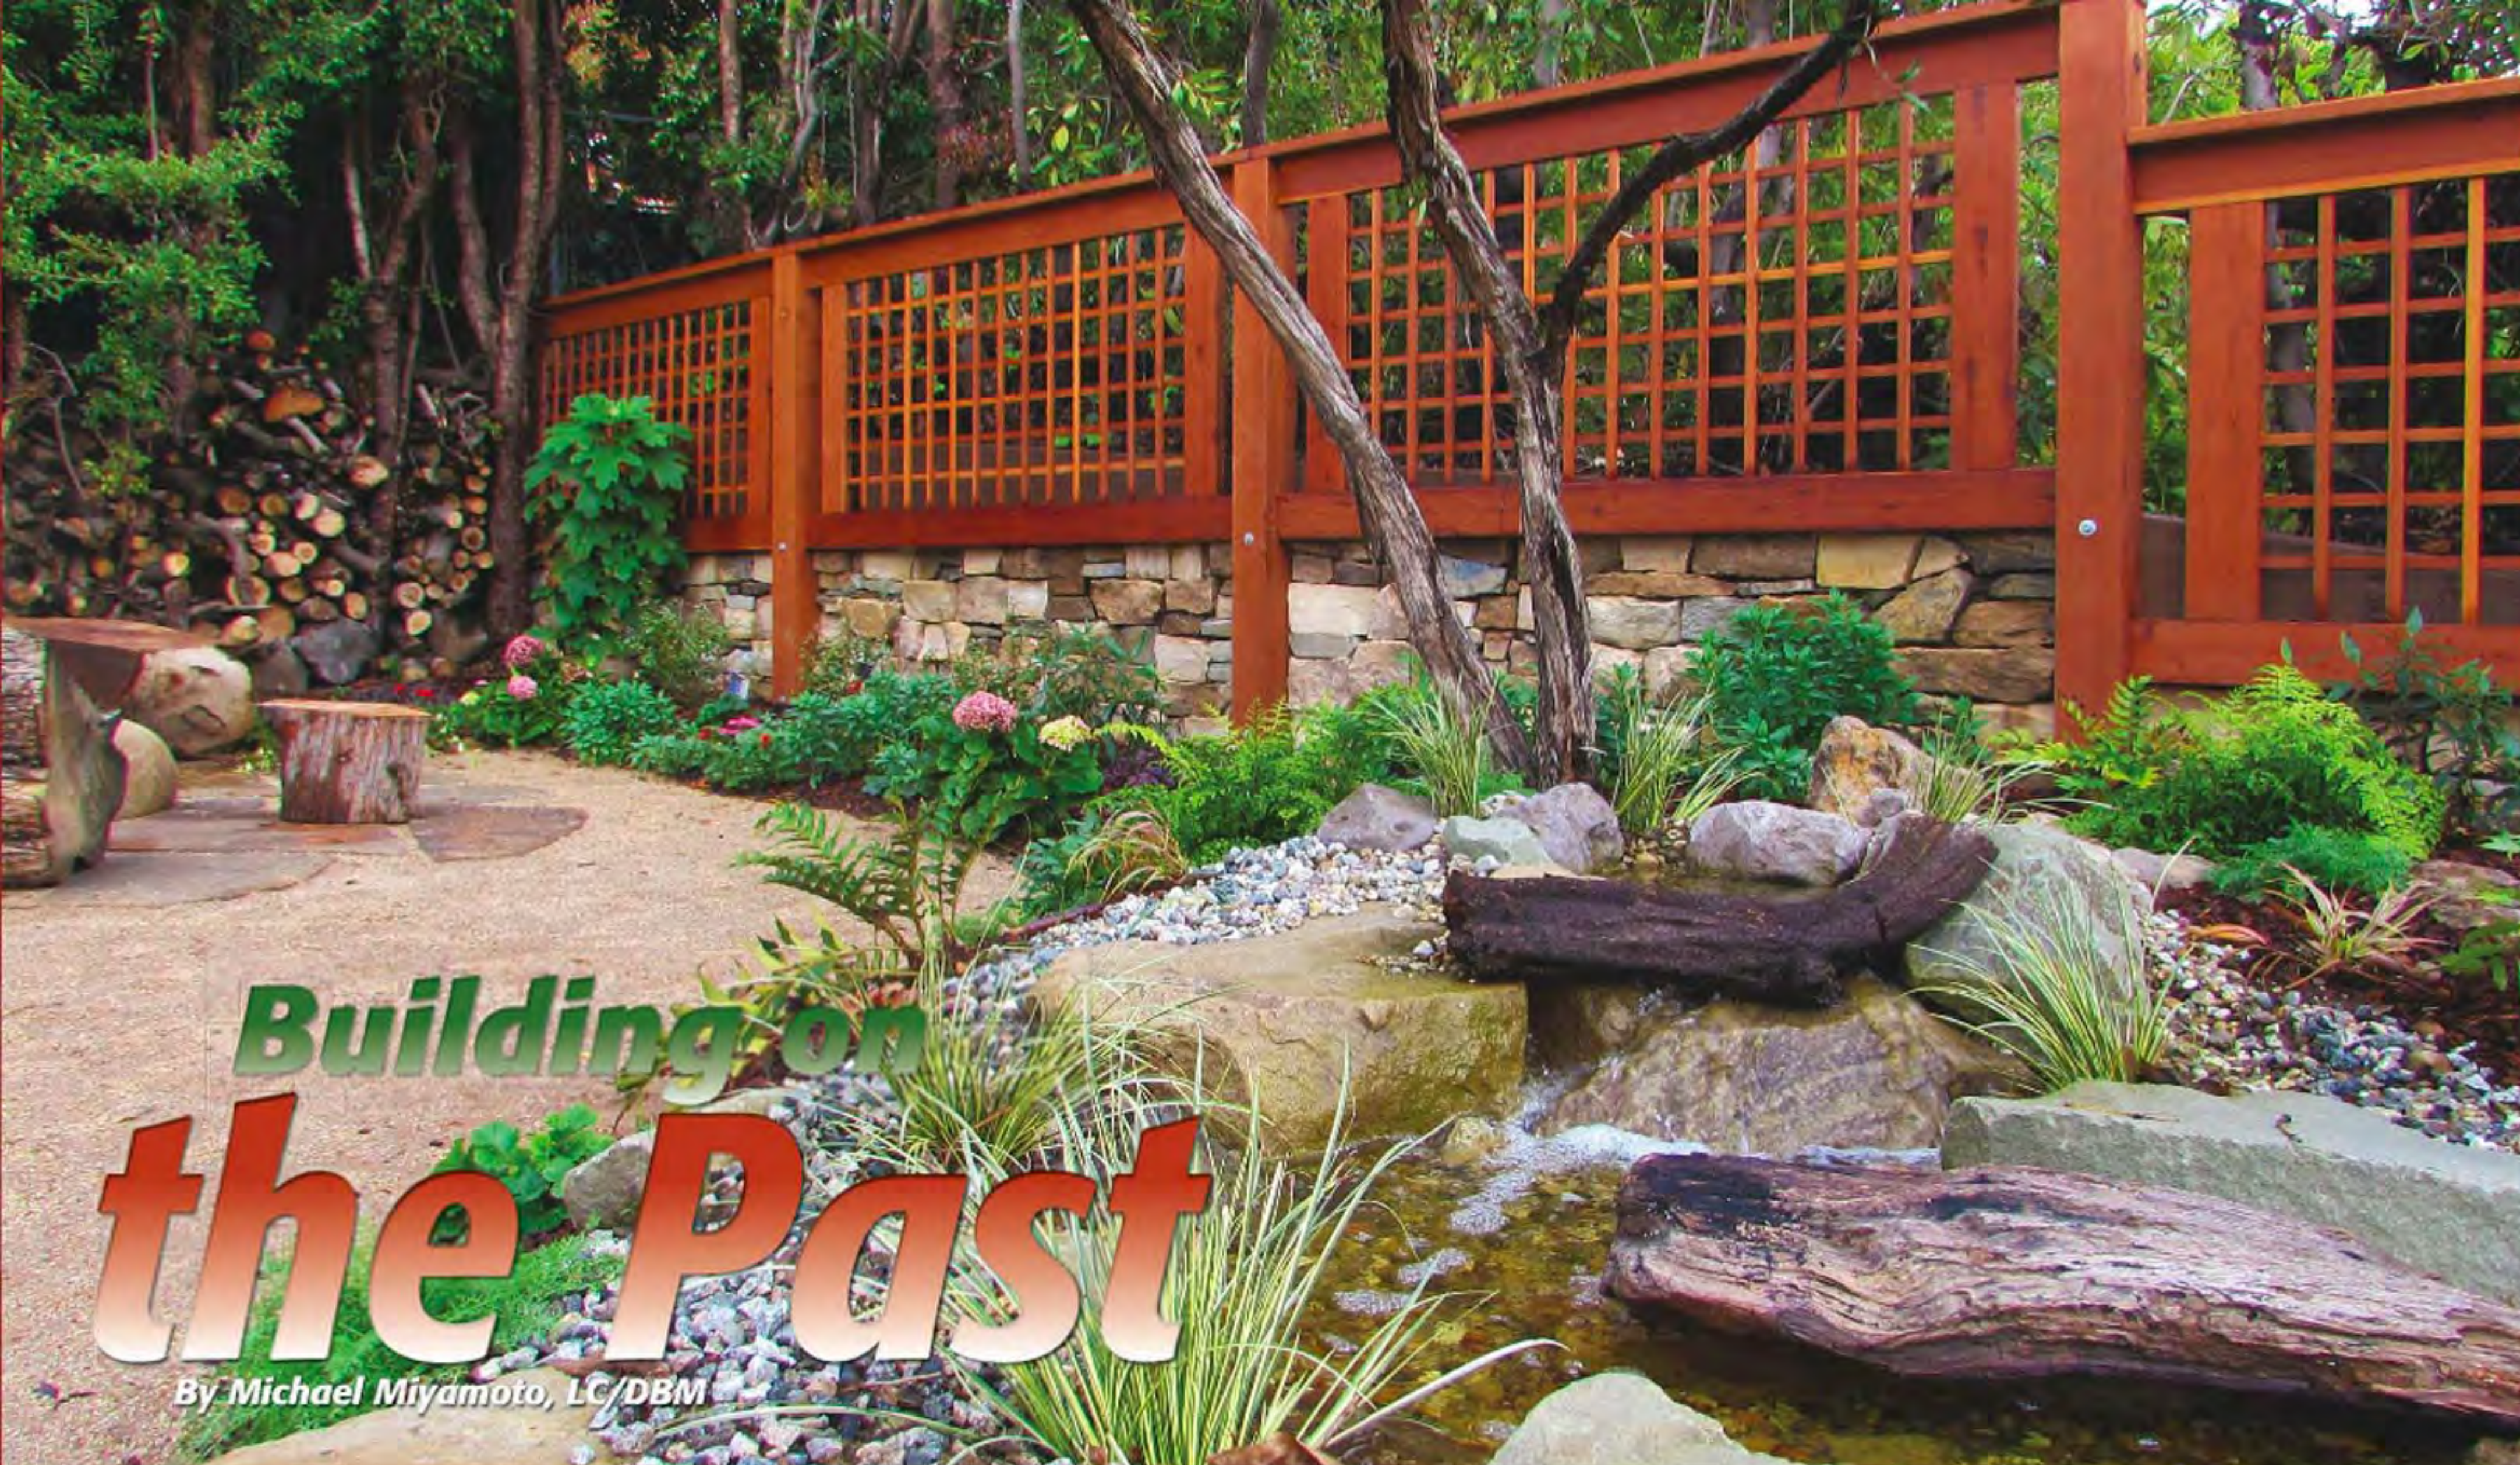
Above: The backyard of this Los Angeles home was redesigned and given a major facelift. Debbie Glikzman, owner of Urban Oasis Landscape, also of Los Angeles, used the existing retaining walls, but had them straightened, repaired and reinforced. Then her workers laid stone blocks along the face and on top of each wall by hand. A new redwood fence was installed along the top of the new stonewall. The project also included a natural water feature on one level, flowing to a tiny pond on a lower level. Giant boulders frame a fire pit, and small and large logs were added to this feature for seating. There are also raised planter beds, flagstone and brick pavers, and lighting and irrigation systems.

Although the existing retaining walls were sturdy, they were cracked and unsightly. Glikzman had her work crew fortify the walls with rebar and concrete, and then laid individual stone slabs by hand over the existing block. This gives the appearance of a dry-stacked stonewall.

Asked whether she encountered any challenges on this job, she said: "The existing retaining walls were crooked and needed to be stabilized. We reinforced them with rebar and filled the hollow spaces with concrete. Getting the stone facing to look like a natural stone wall instead of a veneer took a lot of finessing."

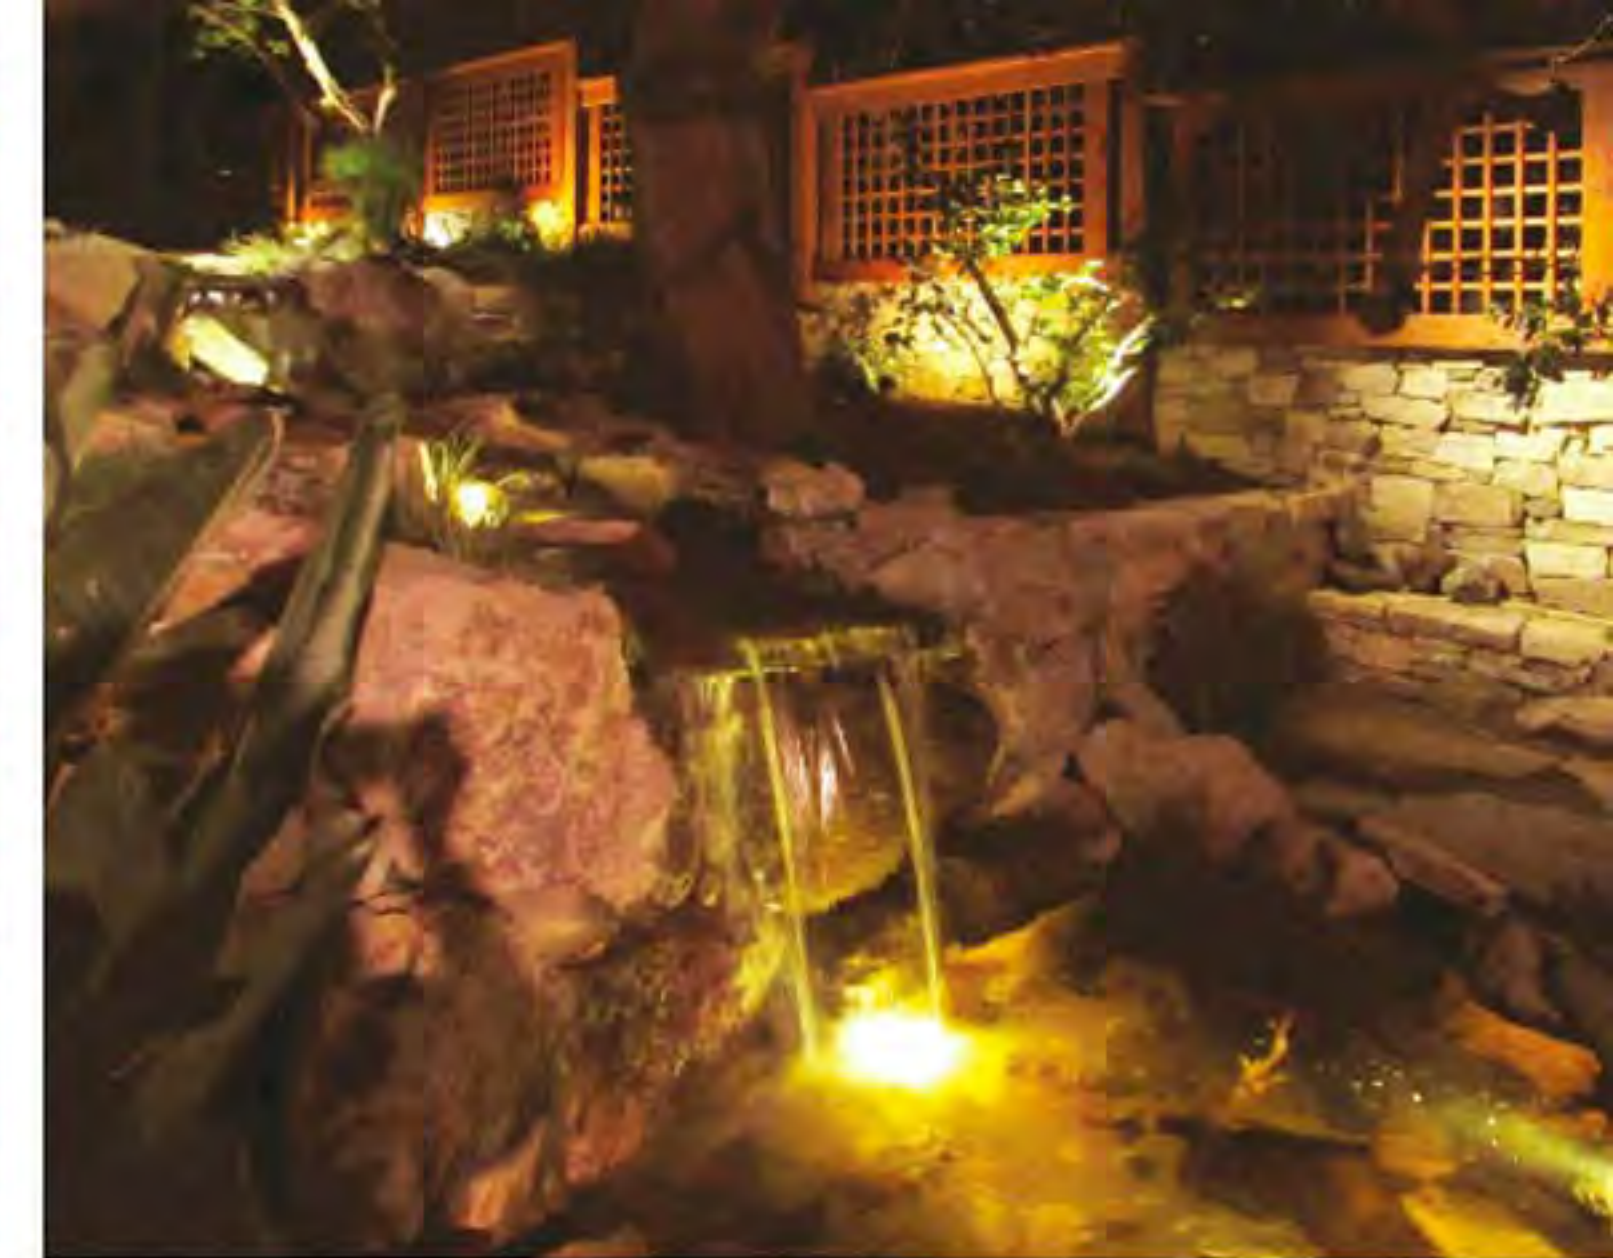
Top, Right: Pacific Outdoor Living installed the water feature and submersible LEDs. Water starts flowing from the water feature on an upper level and cascades down to a tiny pond on a lower level. FX Luminarie manufactured the landscape lights, and Del Rey Electrical installed the lighting system. A total of 41 landscape and submersible lights are in this project.

"A natural water feature starts at the top level and meanders down to a pond below," she adds. "Giant boulders frame a fire pit and small and large logs are used for seating."

Pacific Outdoor Living built the water feature; David Lightfoot installed the irrigation system; Del Rey Electric put in the lighting; and Israel Inequz installed all the plants.

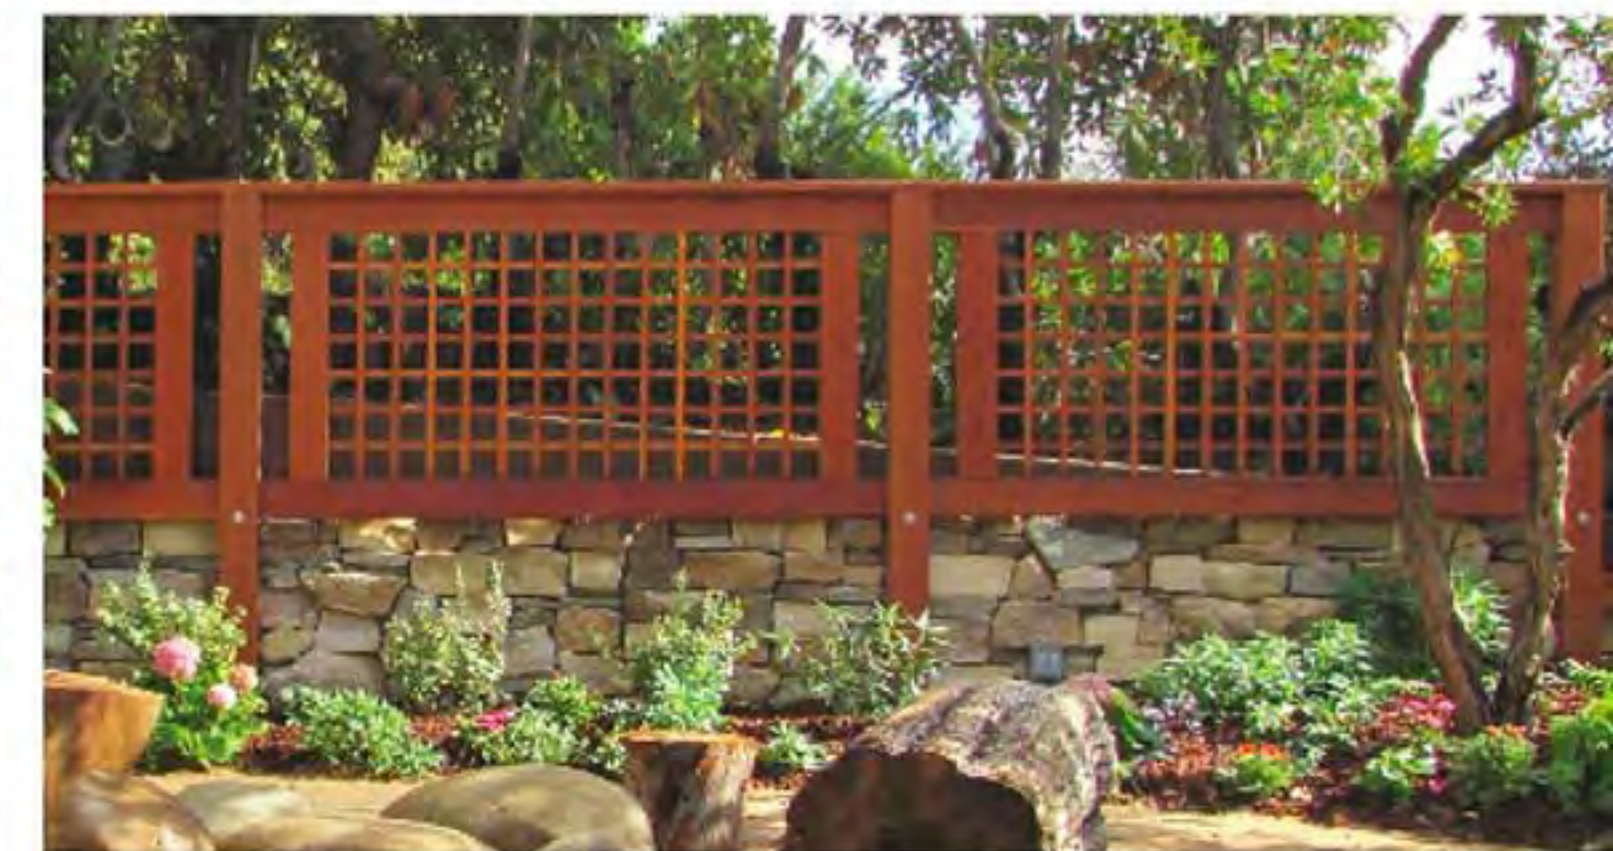
Middle, Right: The fence was custom built by one of Glikzman's subcontractors. It is made entirely of redwood, and the screens are basically trellises. The posts are 6" x 6" and the trellises are 1" x 1/2". The railings are 2" x 4". The fence was placed atop the existing retaining wall. "Getting the stone facing to look like a natural stonewall instead of a veneer took a lot of finessing," Glikzman said.

Francisco Sierra was the contractor for the job, and one of his friends, Victor Vasquez, was the carpenter who put together the wooden fence. The fence was built with redwood, and the screens for it are custom trellises that Vasquez also made

out of redwood. The posts are 6" x 6" and the trellises are 1" x 1/2".

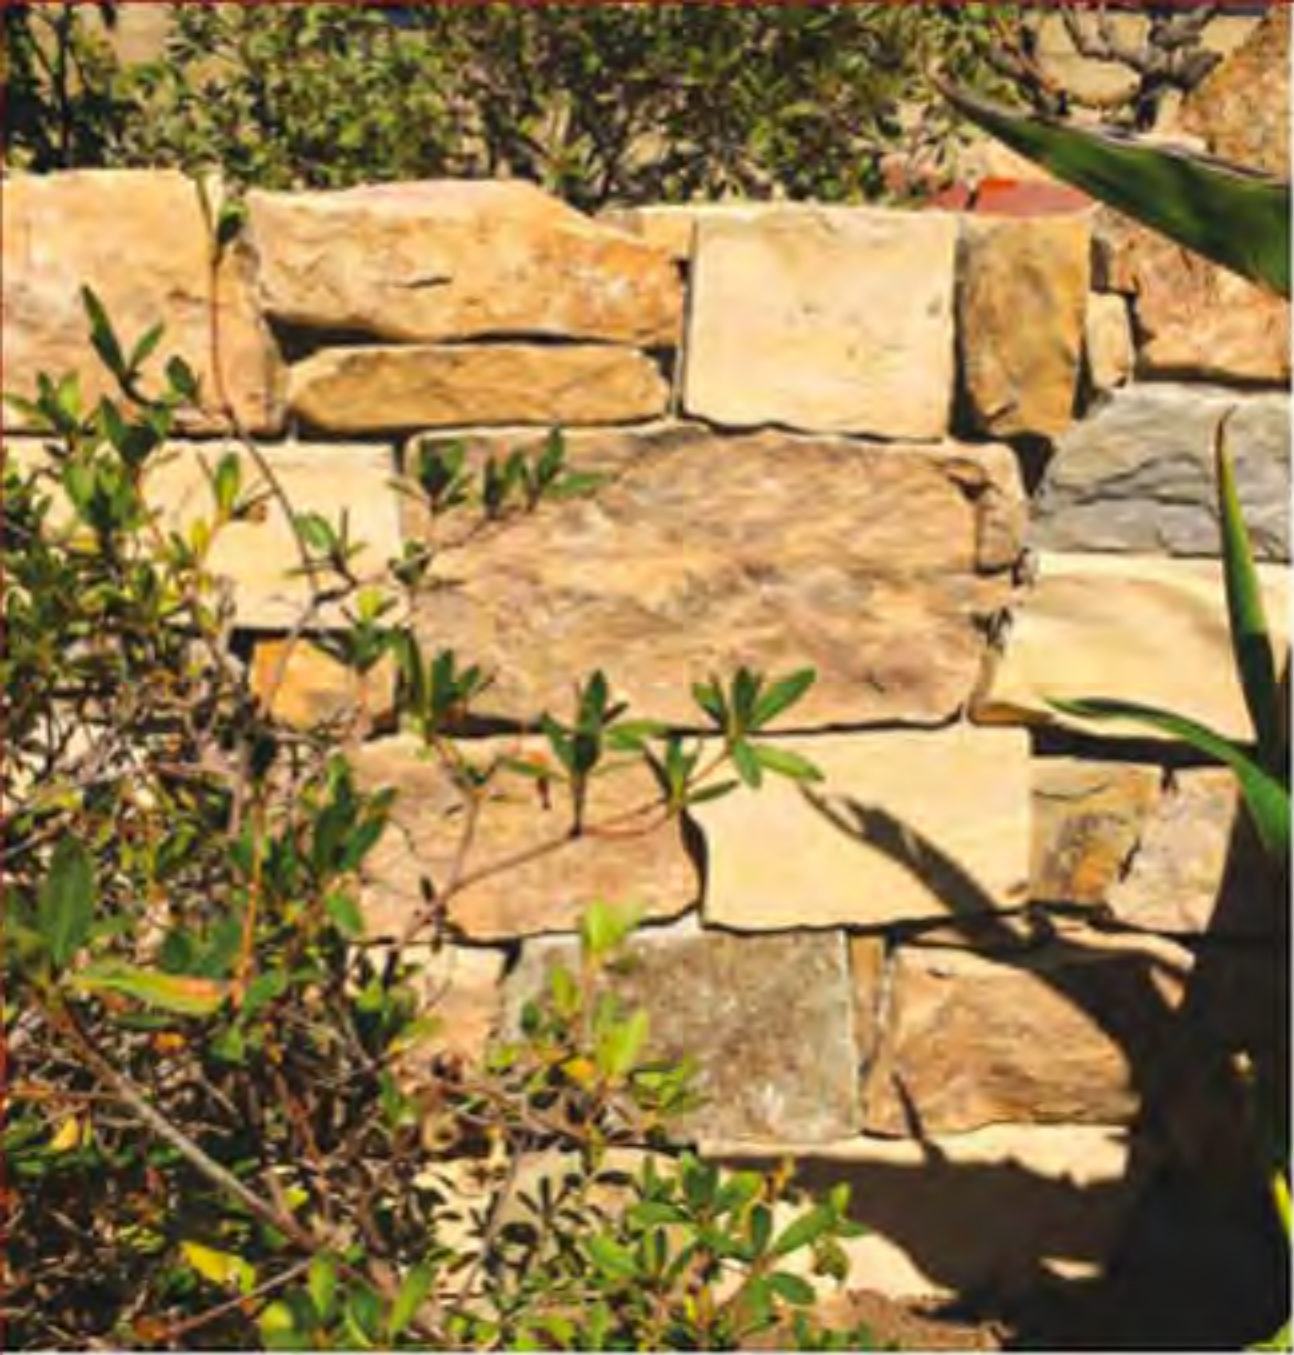
Top, Left: Although the existing retaining walls were sturdy, they were cracked and unsightly. Glikzman had her work crew fortify the walls with rebar and concrete, and then laid stone by hand on the facing side of the existing wall, as well as its top. This gave the appearance that this feature is dry-stacked. Each piece was mortared in place, but not grouted. No footing was required for this fence job, because the existing retaining wall has one already in place. The stone used for the walls was a combination of Monterey Cream, Deer Creek and McGregor Lake ledgestone and Yosemite Quartzite — all from a local supplier, Bourget Brothers. The company also sized each stone piece to Glikzman's specifications.

The stone used for the walls was a combination of Monterey Cream, Deer Creek and McGregor Lake ledgestone and Yosemite Quartzite — all from a local supplier, Bourget Brothers. The company also sized each stone piece to the builders' specifications. Sweetwater flagstone and brick were used as paving materials.

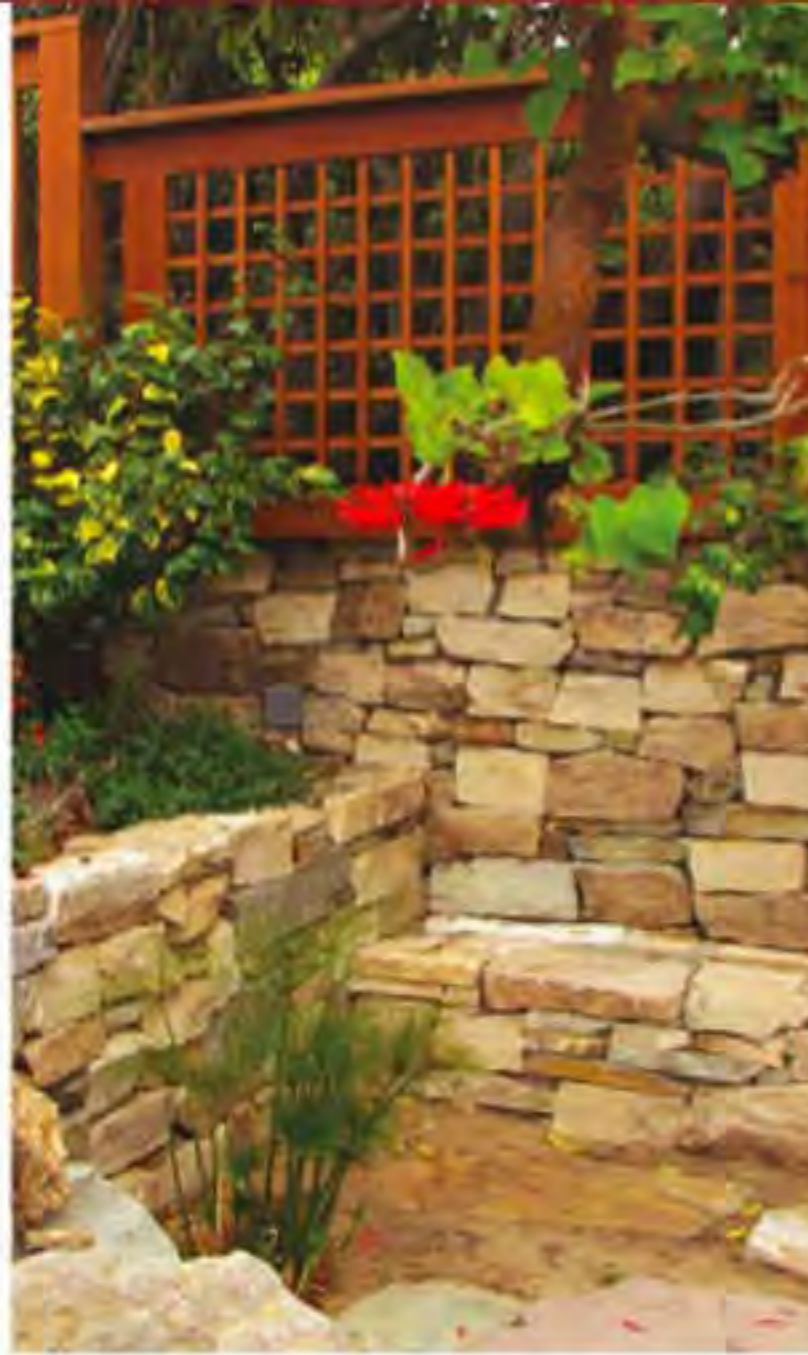
Top, Right: The 6" x 6" posts are buried in the ground and bolted to the existing wall, which already has a footing. So the fence is well supported by the wall, Glikzman said.

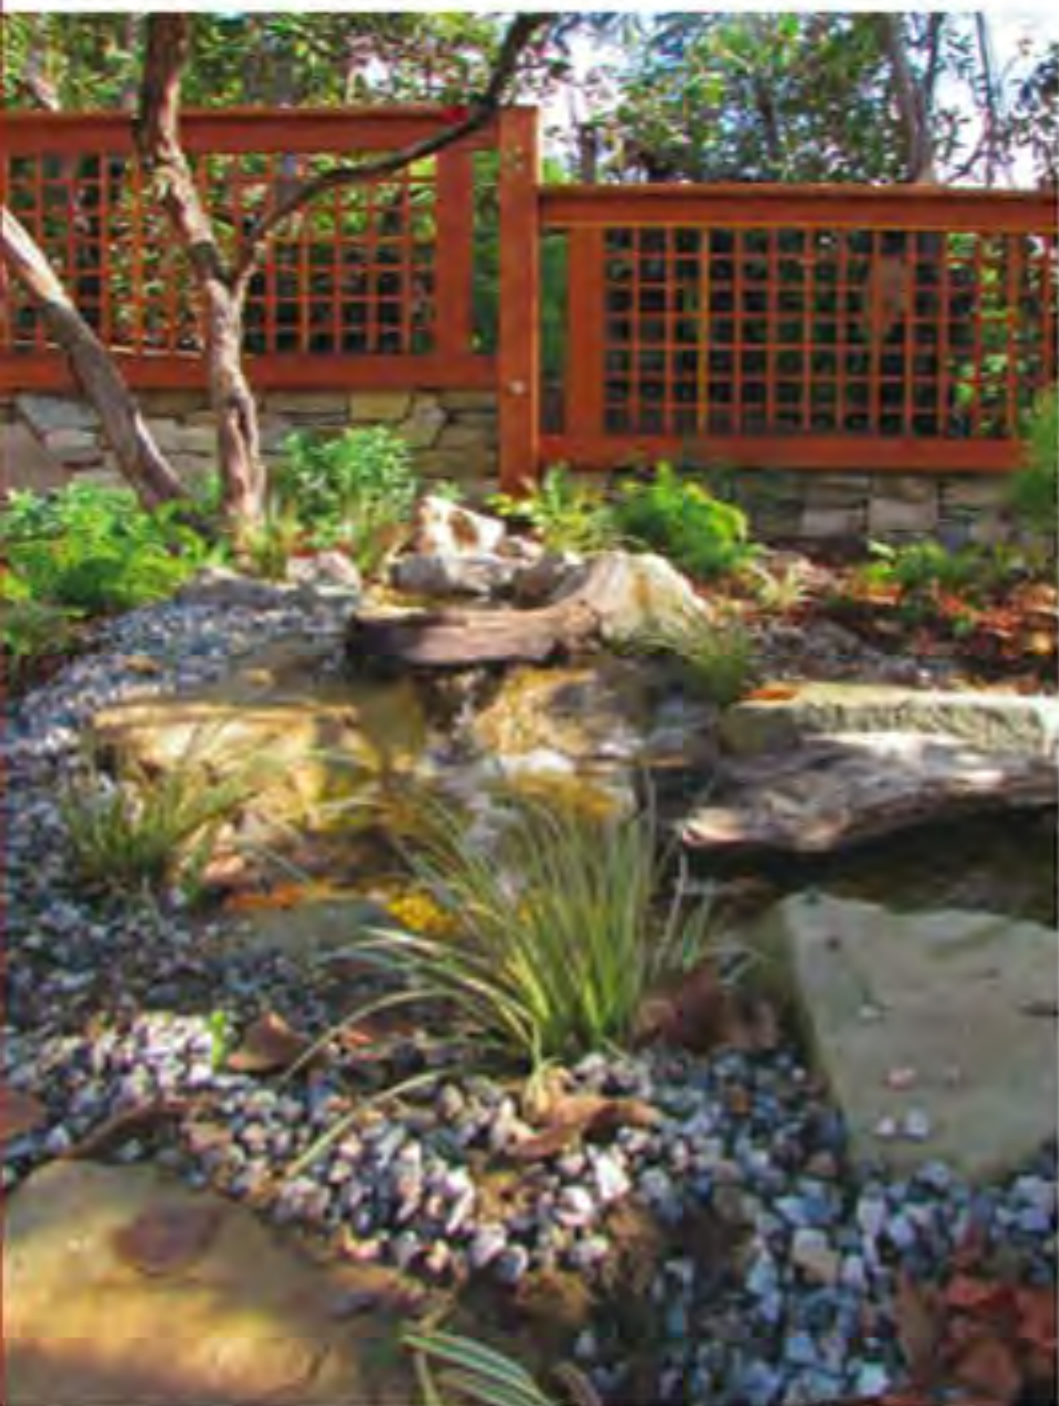
Bottom, Left: Generic boulders, river rocks, gravel and pebbles were used for the bed of the manmade stream.

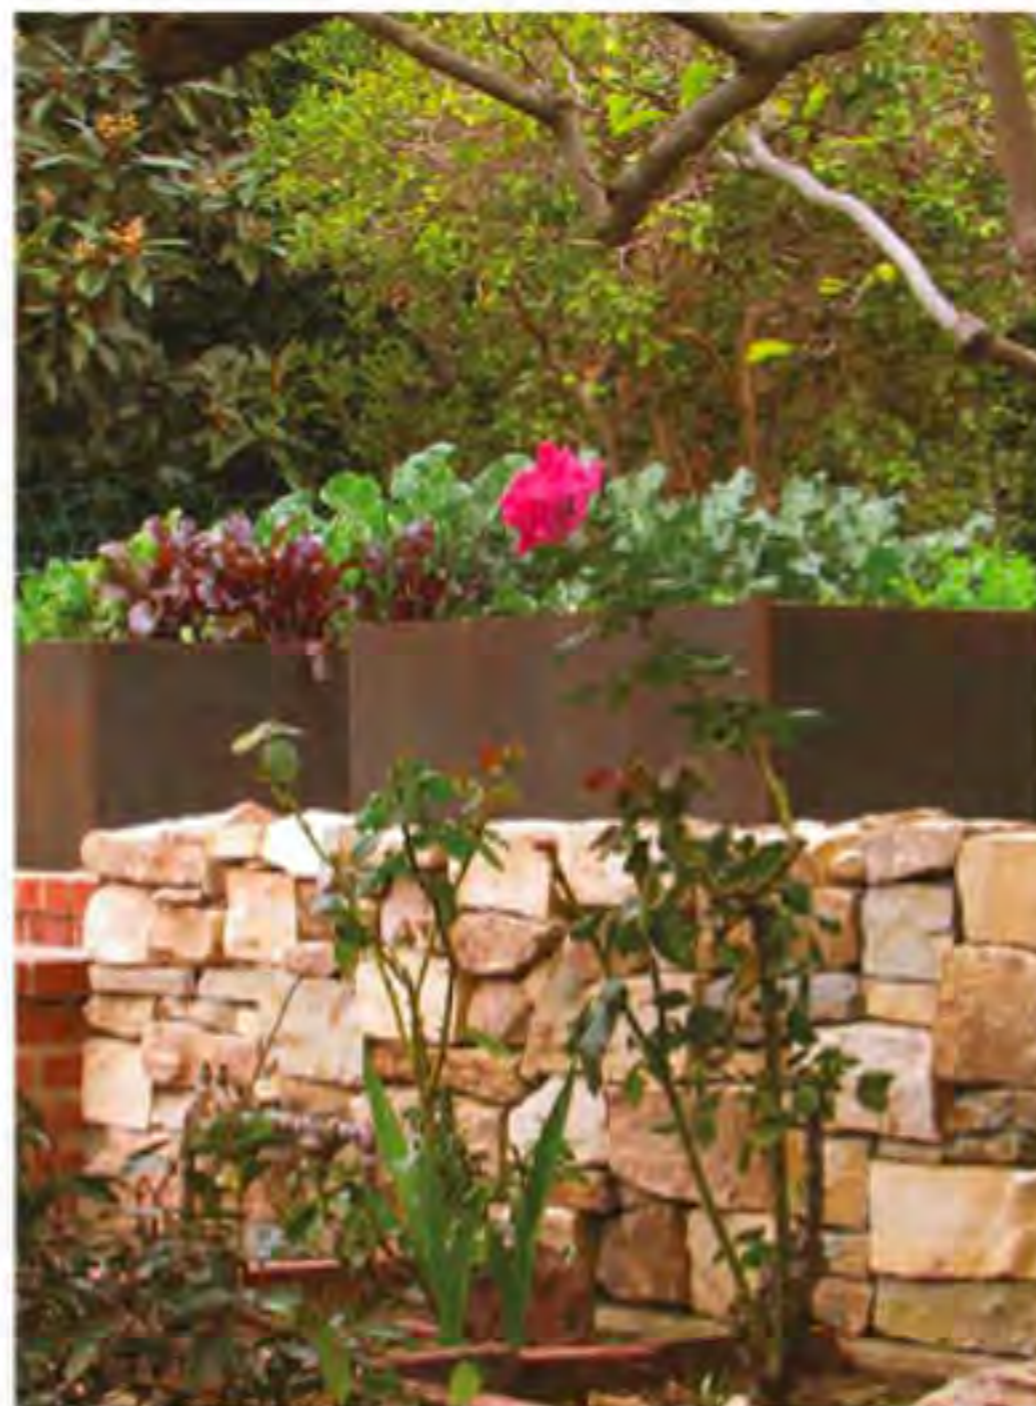
Bottom, Right: Sheets of COR-TEN steel, fabricated by Jaime Gracia of Gracia Designs, were used to create raised planter beds. Francisco Sierra, a subcontractor, installed flagstone and brick paving materials, repaired and reinforced the existing retaining wall and handcrafted the new stonewall.

Glikzman also included five enormous raised planter beds enclosed with COR-TEN steel in the project, all of them to grow vegetables because her client is an avid vegetable gardener. The client's backyard also has many fruit trees, berry plants and grape vines, so it's a virtual "food grower's heaven," Glikzman said. Jaime Gracia, of Gracia Designs, fabricated the COR-TEN material for the raised planter boxes.

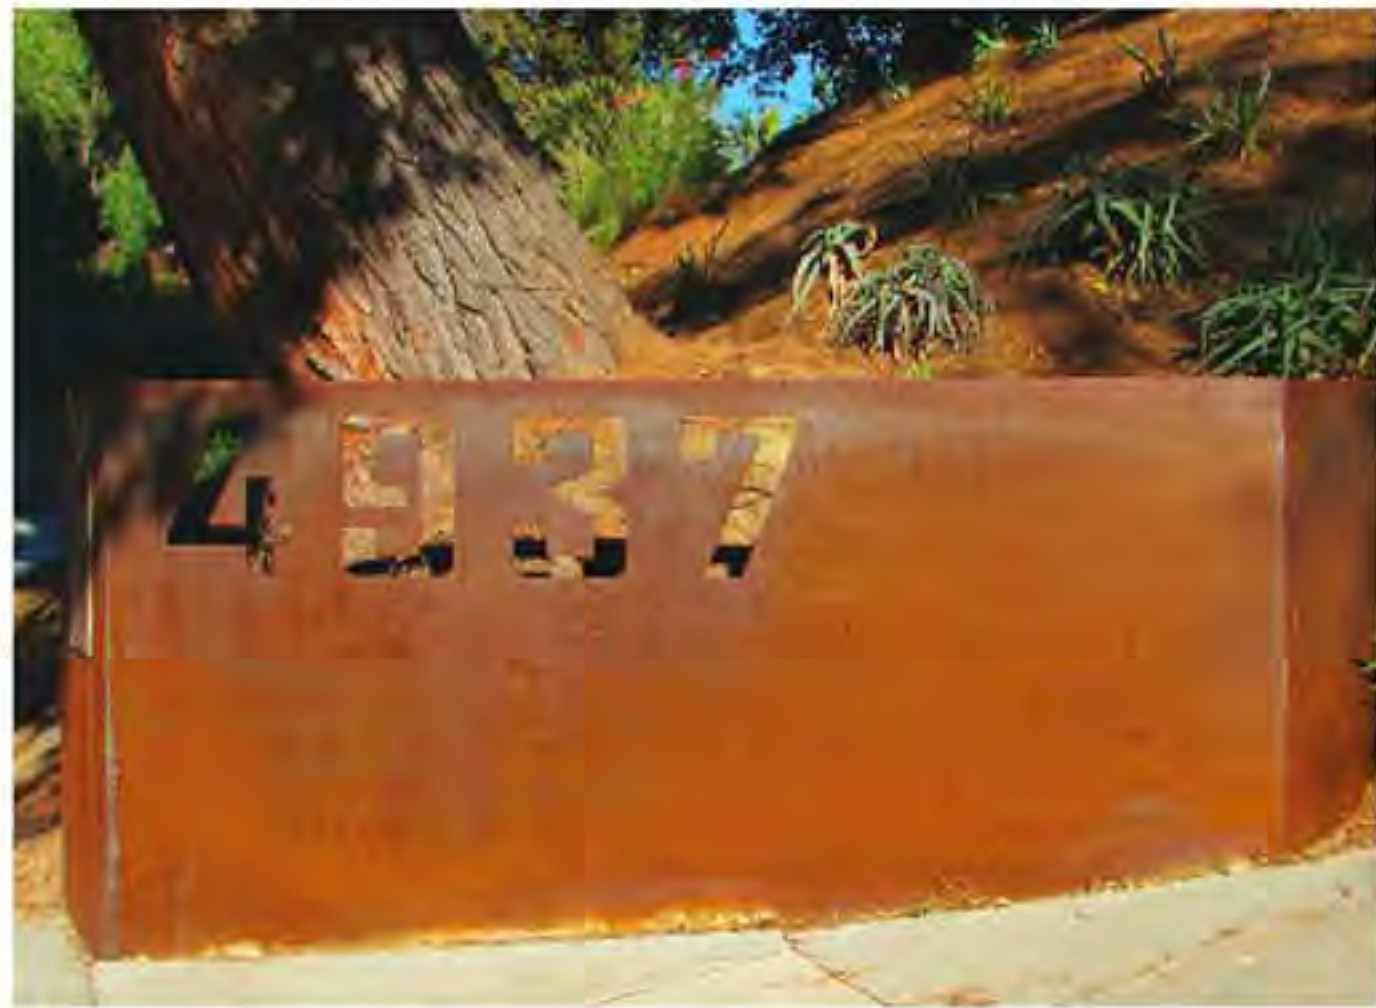
Debbie Gliksman of Urban Oasis Landscape, designed and supervised the installation of a fence, drought tolerant garden, deck, steps and more at this home in Tarzana, Calif. The job also included a decorative screen that was installed against an empty slope too steep to plant. The screen is made of COR-TEN, or weathered steel, which has a naturally oxidized finish that forms a stable rust-like appearance. Jamie Gracia, of Gracia Design, fabricated the screen, and also cut out the house address numbers, creating a graphic visual statement.

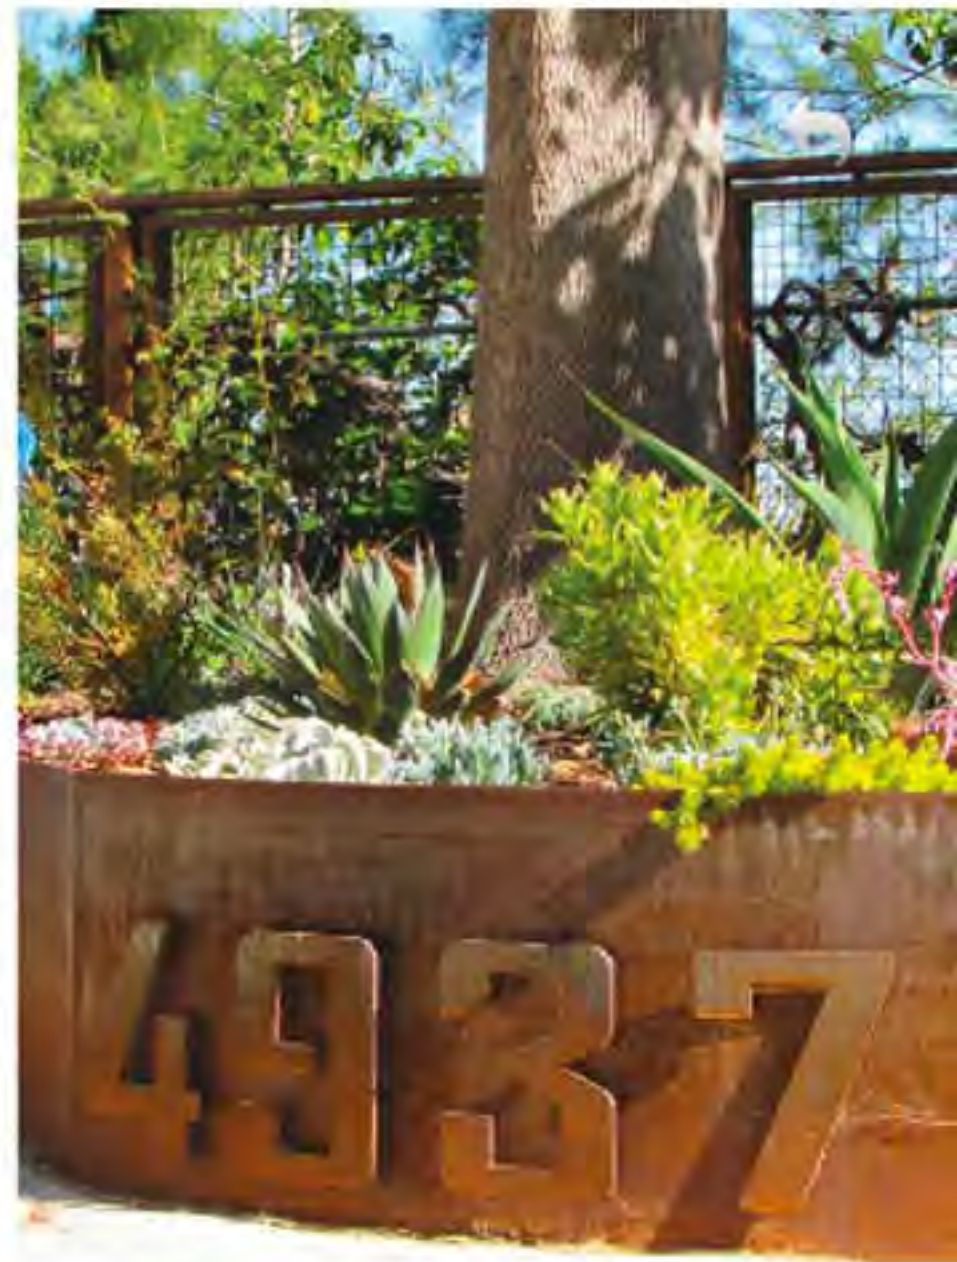
The numbers that were cut out were then applied to this COR-TEN raised planter bed at the entrance of the same home: another good example of how imagination and innovation can come from fencing projects.

David O. Lightfoot of David Lightfoot Landscapes, designed and built the fence behind the planter box. It was designed as a swimming pool security fence that would be pleasing to the eye and not block the view from the property. The redwood frame was made with 4" x 6" posts and 2" x 6" caps. The fence has 5' x 5' panels with 1-1/2" square steel mesh fastened to the back of mitered 2' x 4' redwood frames. The wood has a semi-transparent finish, while the metal mesh was left unfinished.

A concrete continuous grade beam was poured with steel (Simpson PB) post bases set in. The 4' x 6' posts were mounted and the 2" x 6" caps were fastened to run continuously. The 5' x 5' panels were fabricated on site and suspended in each frame with uniform spacing (long construction screws and cylindrical spacers). The finish was applied after construction.
